Installation of 1-10-050 Kit, Reinforcement Bracket, Trunion Field Fix

Date: August 14, 2009

Model: GO-4 Interceptor III

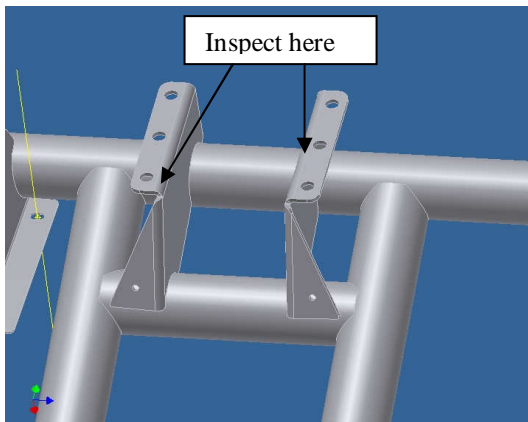
Figure 1. Old designed trunion plate.

Occasional cracking has been evidenced in the bend area of trunion plates shown in Figure 1. Kit, Reinforcement Bracket, Trunion Field Fix (P/N: 1-10-050) is designed to correct this coincident.

Inspect the flanges of both LH and RH trunion plate as shown in Figure 1. If the trunion plate is **NOT** cracked, **Instruction A** should be followed. If cracking has occurred, **Instruction B** should be followed.

NOTE: No matter how small the crack on the trunion plate, **Instruction B** should be followed.

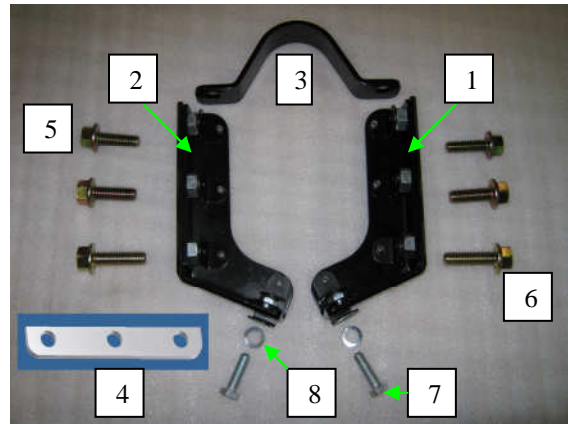
Figure 2. Component included in the Kit

Kit, Reinforcement Bracket, Trunion Field Fix (P/N: 1-10-050) includes the following components shown in Figure 2.

ITEM	PART NO	DESCRIPTION	QTY
1	1-10-354	Assy, Reinforcement Bracket, LH, Trunion Field Fix	1
2	1-10-355	Assy, Reinforcement Bracket, RH, Trunion Field Fix	1
3	1-53-434	Reinforcement Strap, Trunion Field Fix	1
4	1-10-356	Shim Plate, Trunion retrofit	2
5	774366	1/2-13 UNC x 1.5in Gr8 ZP Hex Flange Lock Bolt	4
6	774404	1/2-13 UNC x 1.75in Gr8 ZP Hex Flange Lock Bolt	2
7	774286	3/8-NFx1-1/2 ZP Gr 8 Hex Hd Bolt	2
8	771150	3/8 Std Lock Washer	2

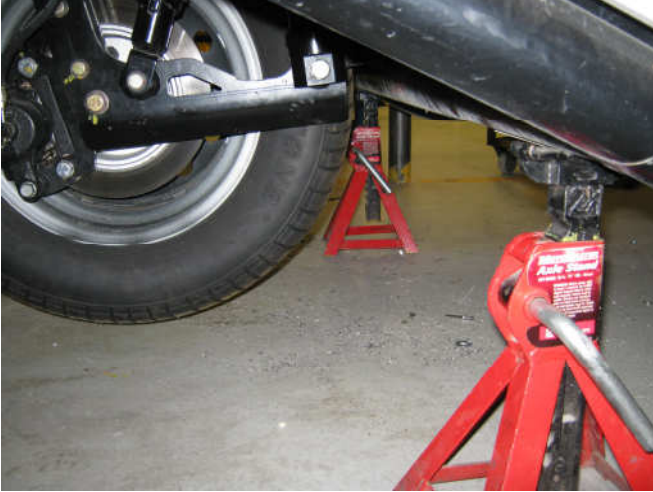
Figure 3. Lift and support the unit

Lift and support the unit as shown in figure 3 until the front wheel is above ground.

The front wheel has to be lifted off ground, otherwise damage and serious injury may occur.

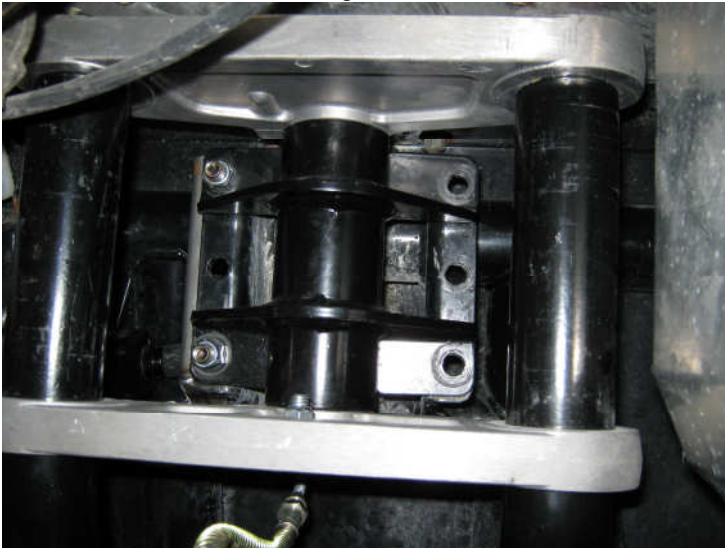
Figure 4. Nuts and bolts are removed on LH side

1. Remove the ½” nuts and bolts (Figure 4) **one side at a time**. Discard old hardware.

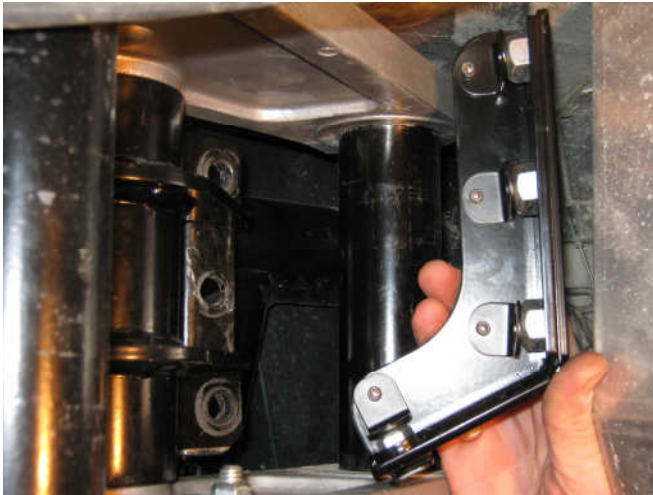
Figure 5. LH Reinforcing bracket assembly

2. LH reinforcing bracket assembly (Figure 5).

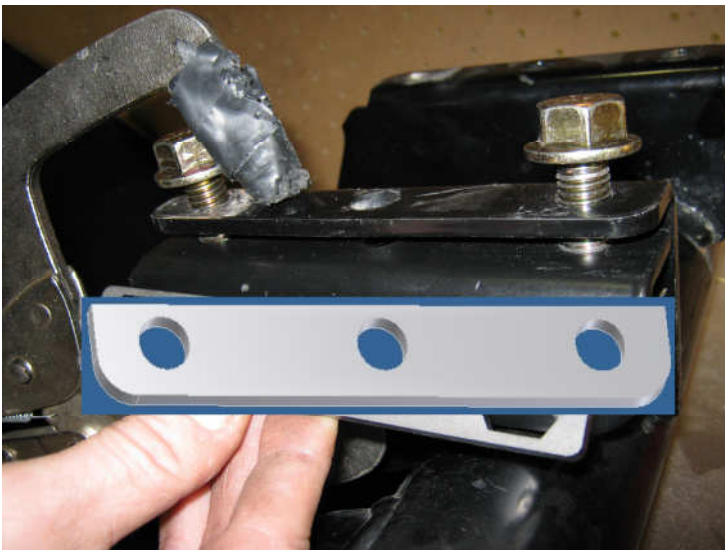
Figure 6. The shim plate fits between the trunion plate and the trunion mount.

3. Try to fit the reinforcing bracket into the trunion plate, screw both top and bottom bolts into the reinforcing bracket to make sure holes line up. Check gap between the flange of trunion plate and the top of the reinforcing bracket. If the gap size is larger than 2 mm, a shim plate should be used (Figure 6).

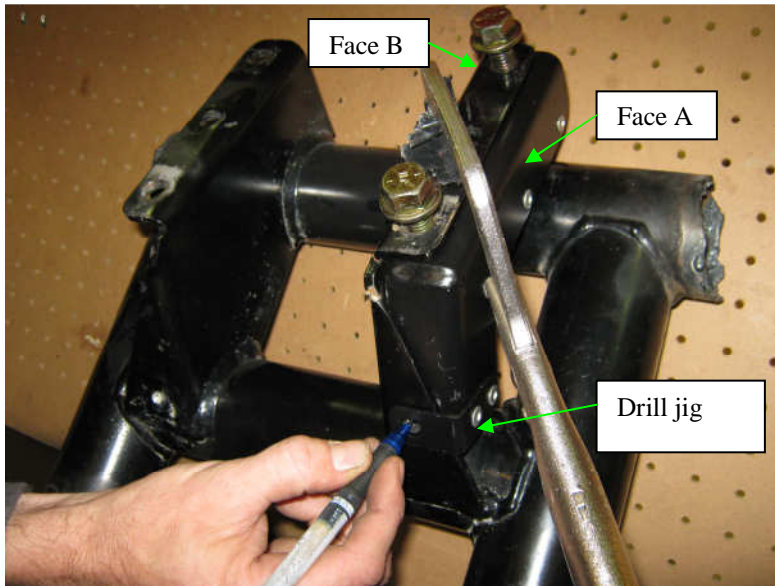
Figure 7. Clamping and marking

4. Clamp the reinforcing bracket and the flange of trunion plate (Figure 7) to ensure face A and B are parallel. If not, apply additional clamp as necessary. Proceed to mark $\frac{3}{8}$ hole location as depicted in Figure 7.

NOTE:
Remove the two 1/2" bolts and clamp again, if the drill jig is hard to fit in.

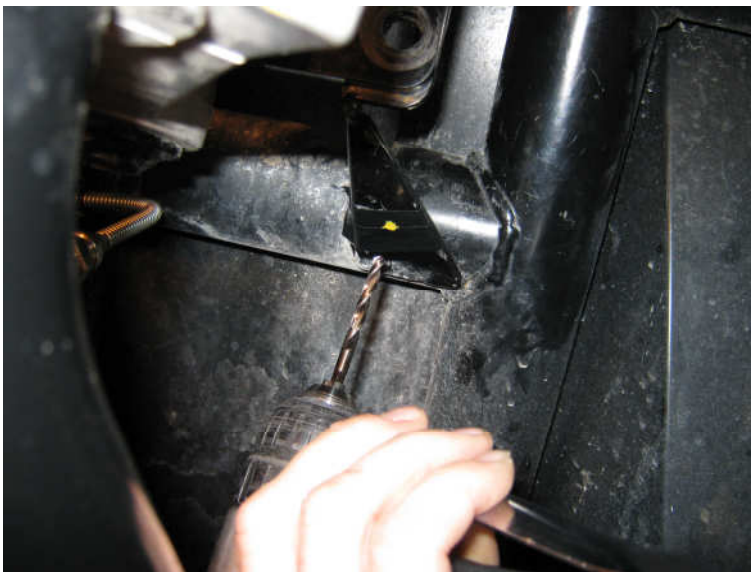
Figure 8. Drill a 3/8" hole

5. Remove the bracket and drill a 3/8" hole using an angle drill (Figure 8).

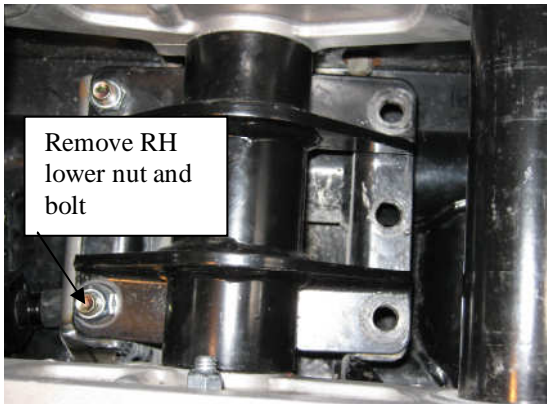
Figure 9. RH lower nut and bolt.

6. Remove RH lower trunion bolt (Figure 9). Put the reinforcing bracket back into the trunion plate and install the reinforcement strap with 1/2" 1-3/4" length bolt as shown in figure 10.

Remove RH lower nut and bolt

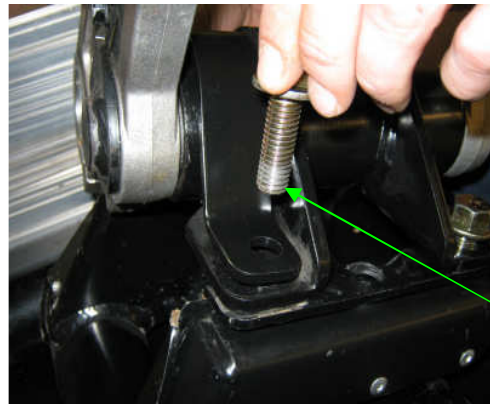
Figure 10. Install reinforcement strap

Apply blue loctite

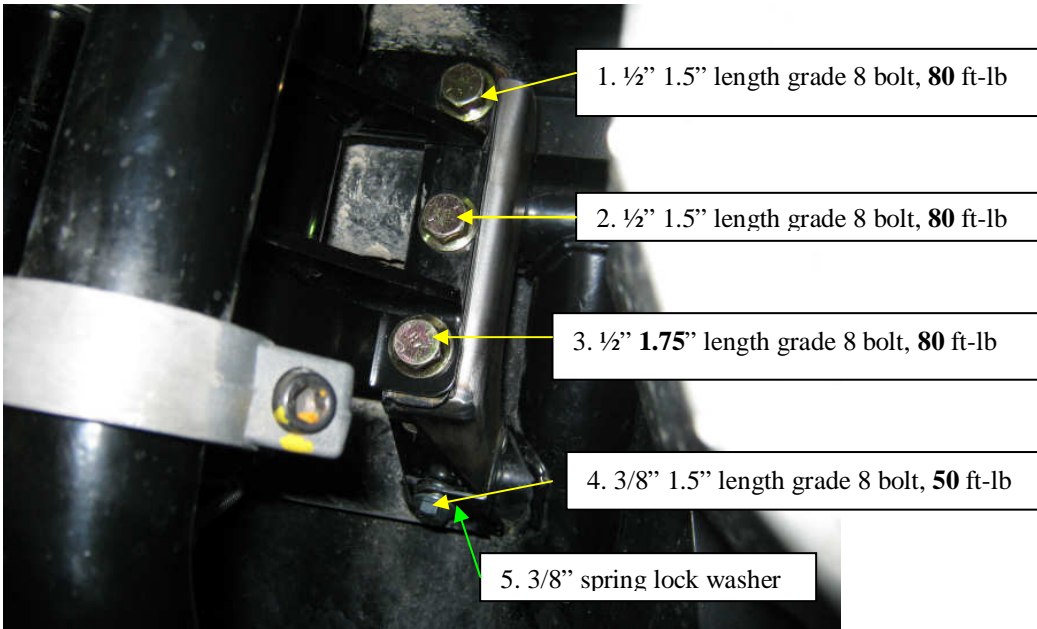
Figure 11. Final fastened bolts

7. Apply **blue loctite** to all 4 bolts. Fasten using applicable torque specs as shown in figure 11.

1. 1/2" 1.5" length grade 8 bolt, 80 ft-lb

2. 1/2" 1.5" length grade 8 bolt, 80 ft-lb

3. 1/2" 1.75" length grade 8 bolt, 80 ft-lb

4. 3/8" 1.5" length grade 8 bolt, 50 ft-lb

5. 3/8" spring lock washer

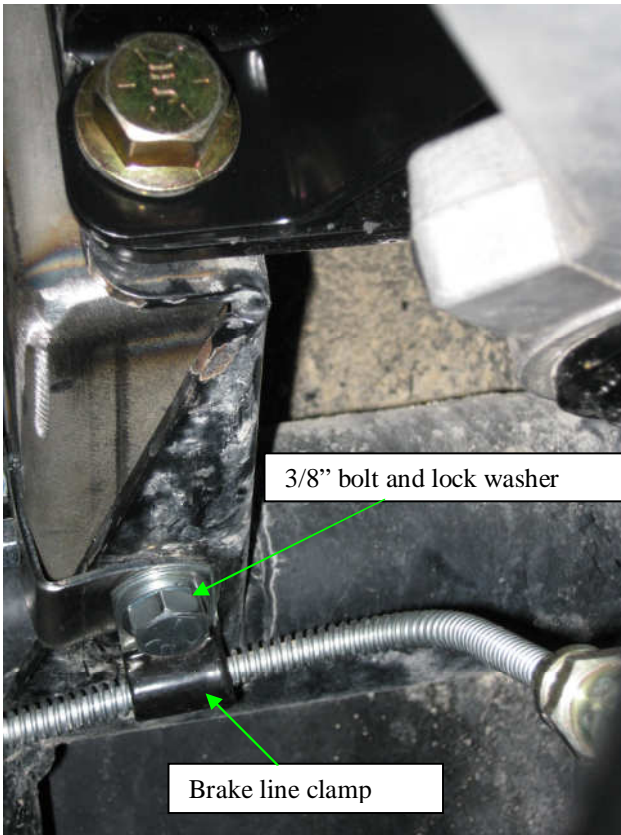
Figure 12 Brake line installations

8. Repeat the above procedures to complete the RH reinforcing bracket installation. The brake line clamp can be fastened by the 3/8" bolt (Figure 12).

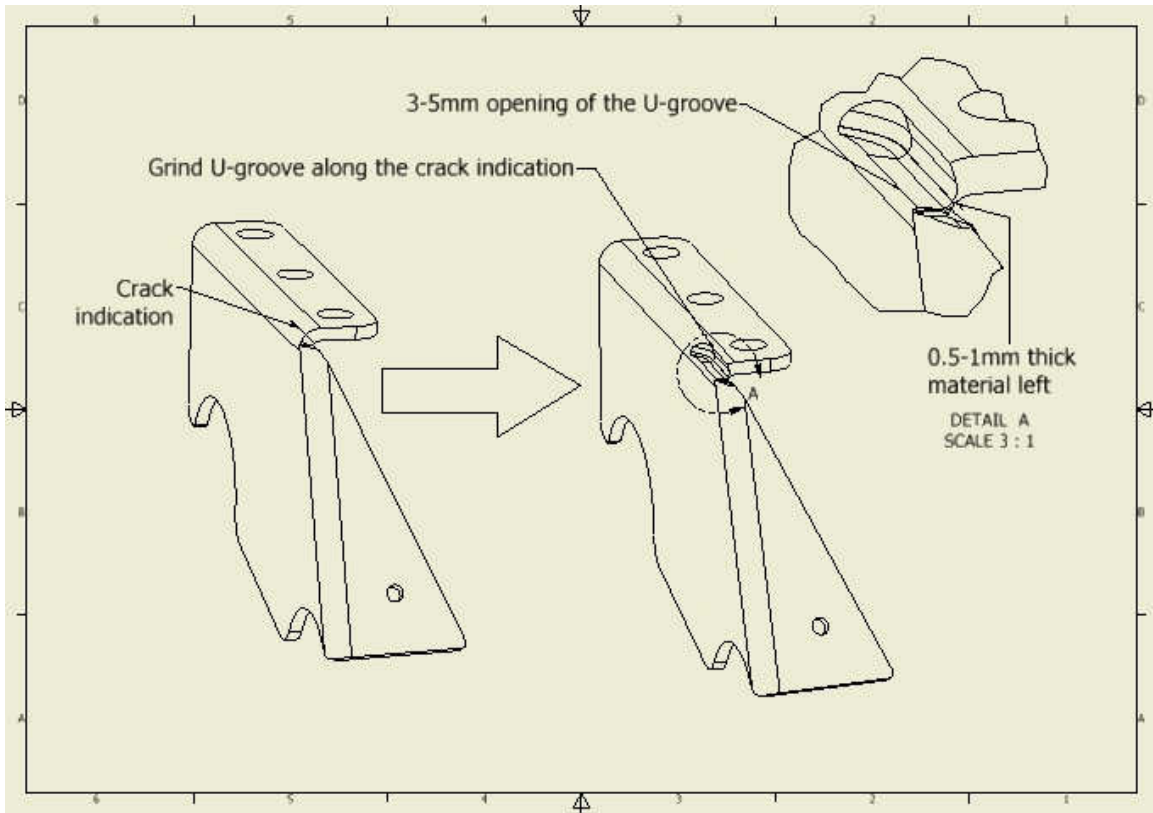
Figure 13. U-groove preparation for welding

1. Remove the front suspension assembly by following the procedure for replacing front suspension trunion mount in APPENDIX.
2. Grind a U-groove along the crack as shown in Figure 13 for both LH and RH trunion plate.

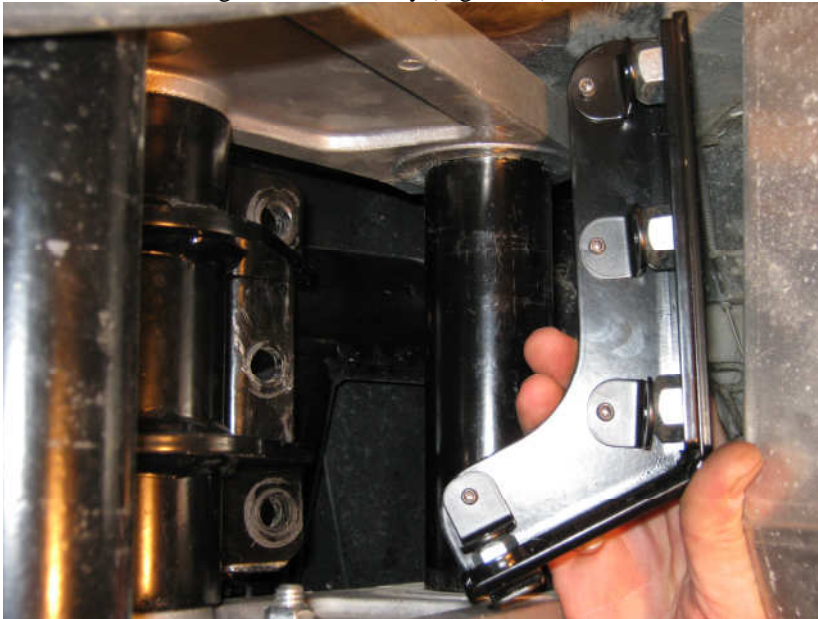
Figure 14. LH Reinforcing bracket assembly

3. LH and RH reinforcing bracket assembly (Figure 14).

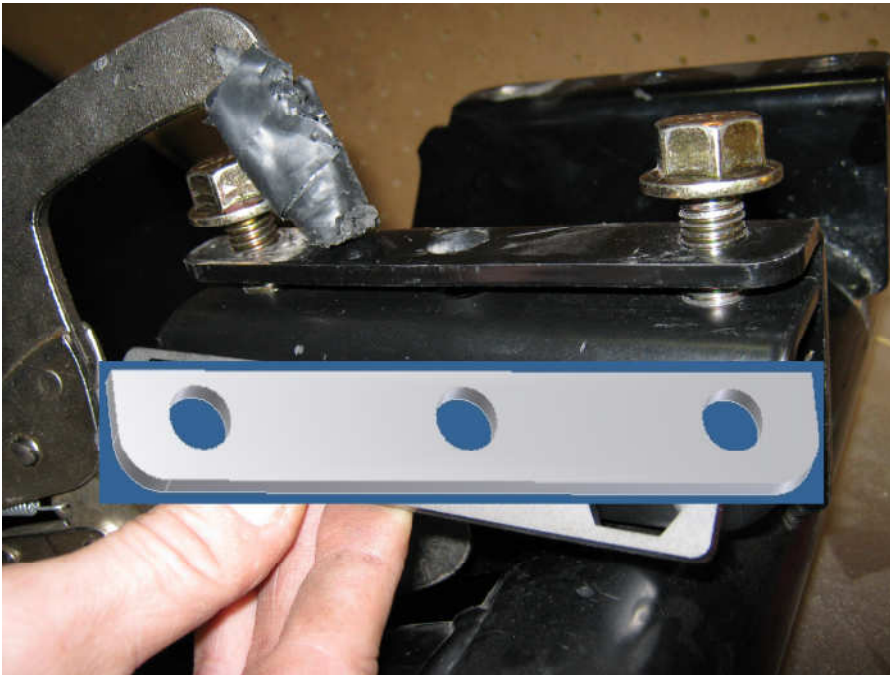
Figure 15. The shim plate fits between the trunion plate and the trunion mount.

4. 3. Try to fit the reinforcing bracket into the trunion plate, screw both top and bottom bolts into the reinforcing bracket to make sure holes line up. Check gap between the flange of trunion plate and the top of the reinforcing bracket. If the gap size is larger than 2 mm, a shim plate should be used (Figure 15).

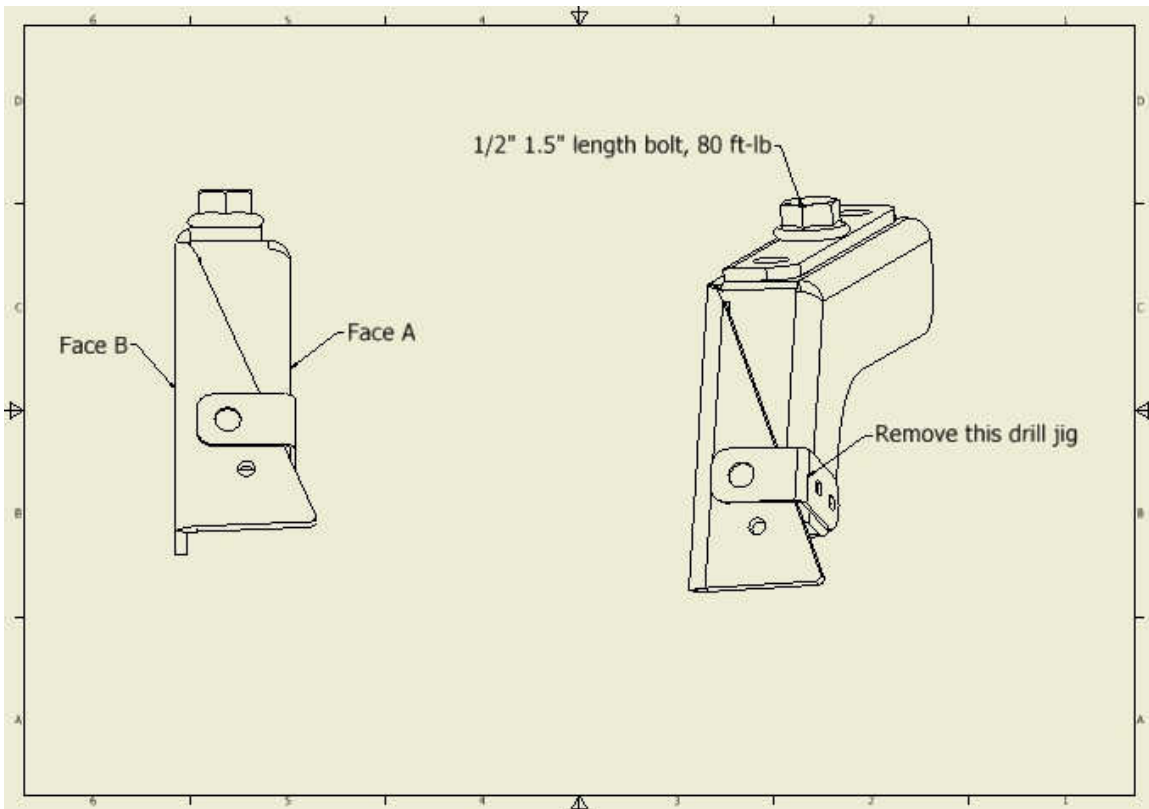
Figure 16 Clamping to make two planes parallel

5. Clamp the reinforcing bracket and the flange of trunion plate (Figure 16) to ensure face A and B are parallel. If not, apply additional clamp as necessary.

6. Tighten the 1/2" 1.5" length bolt to 80 ft-lb (Figure 16). Remove the drill jig.
7. Remove paint on weld 2, 3, 4 and 5. Finish weld as per Figure 17.

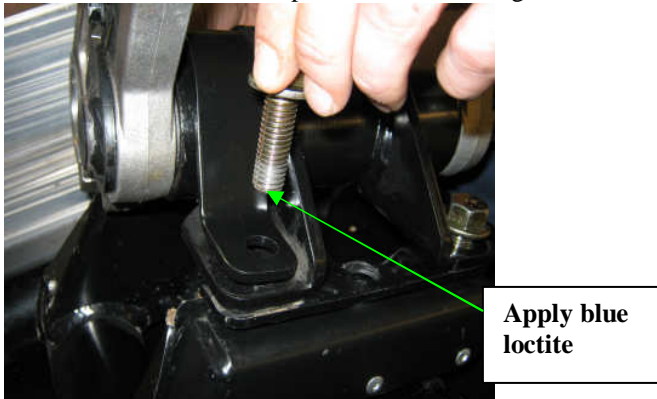
Figure 18. Install reinforcement strap

8. Remove weld spatter from top surface.
- NOTE:** If the surfaces are not cleaned, the weld will interfere in the trunion saddle assembly.
9. Spray paint welded area.
10. Reinstall the front suspension assembly by following the procedure for replacing front suspension trunion mount in APPENDIX.
11. Install the reinforcement strap with 1/2" 1-3/4" length bolt as shown in figure 18.

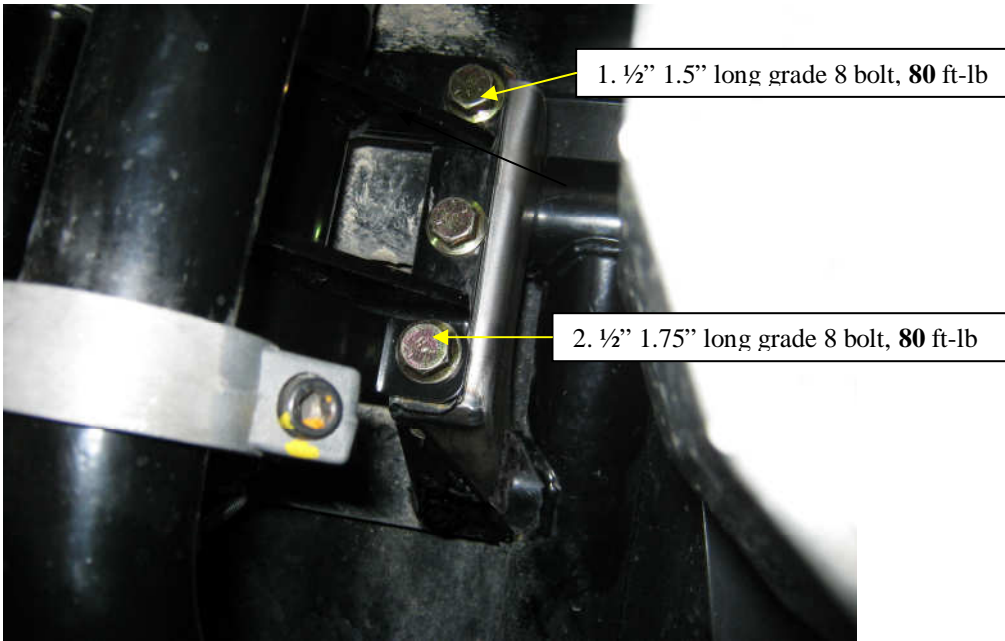
Figure 19. Final fastened bolts

12. Apply **blue loctite** to all bolts. Tighten to the torque shown in figure 19.
